SUMMARY REPORT
GROUND PROJECT SURVEYS
FOR THE QUARTER ENDED
MARCH 31, 2006

SIGIR PA-06-052
JULY 31, 2006

SUBJECT: Summary Report Ground Projects Surveys for the Quarter Ended
March 21, 2006 (Report Number SIGIR-PA-06-052)

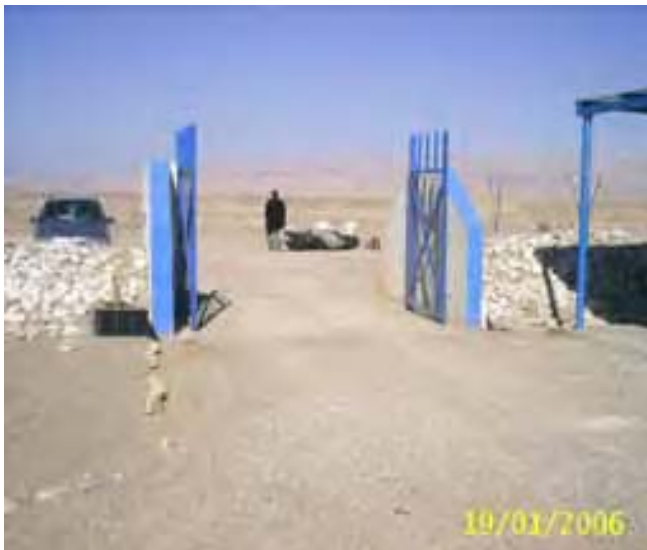
A review of the report and photos provided by the QC/QA teams determined that overall, the site associated with Task Order 0034, Project 12826, appeared to be complete and consistent with contract requirements. A perimeter berm surrounded the post and a gate was located at the entrance. Site Photo 1 shows the perimeter security berm and entrance gate. The site also contained the border post, jail facility, two electrical generators and fuel tank mounted on a concrete pad, covered parking area, and water tanks set on a concrete base. Site Photo 2 shows the exterior side of the border post.

**Site Photo 1: Perimeter security berm and entrance gate
(Project 12826)**

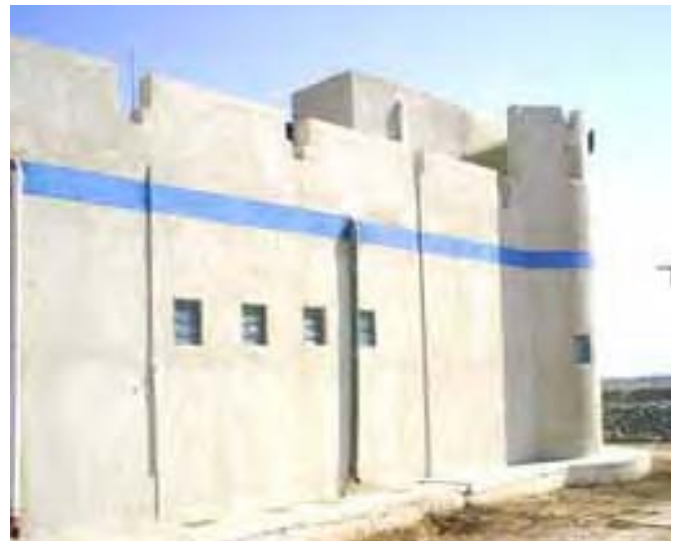
**Site Photo 2: Exterior side of border post
(Project 12826)**

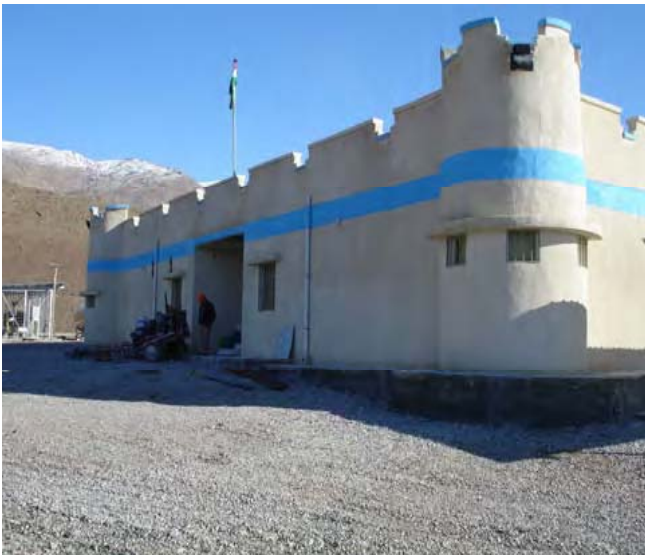
- No perimeter security fences or gates were present. Site Photo 3 shows the exterior view of the border post.
- Structural steel retrofit required due to deflection of I-beams was in-progress. Site Photo 4 shows the structural steel retrofit.
- Spot welds on generator roofing appeared to be of poor quality.
- Potable water was reported trucked in for use and users reported they are concerned about the quality and quantity of the water. No filtration or sterilization (except boiling) of the water was available.
- The access road was difficult to use, especially during the rainy and snowy seasons.

Site Photo 3: Front view of border post (Project 12786)

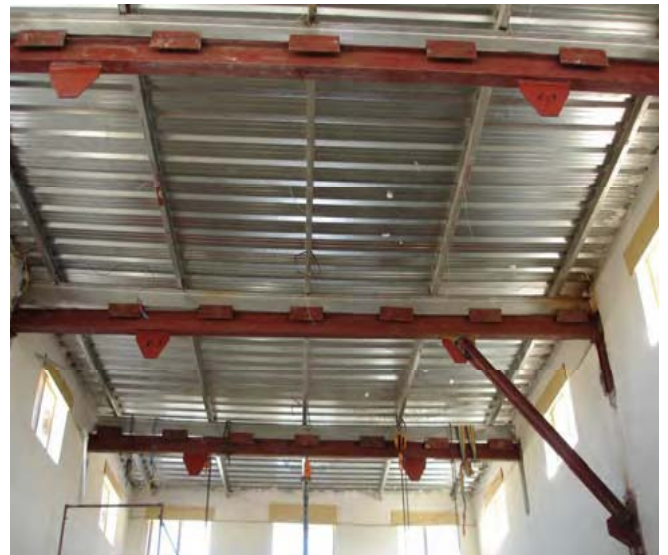
Site Photo 4: On-going structural retrofit (Project 12786)

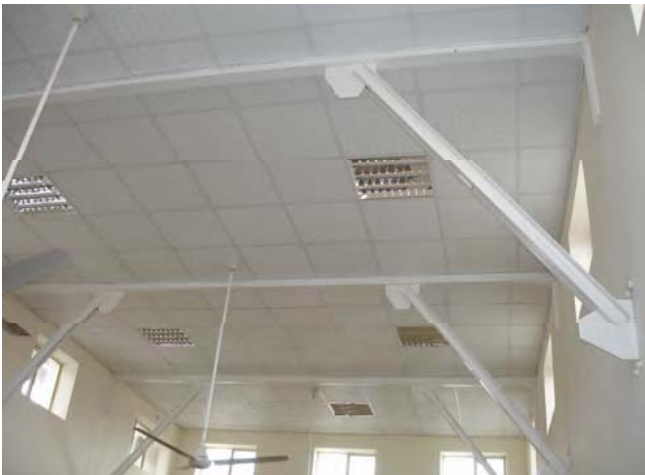
Site Photo 5: Completed structural retrofit (Project 12807)

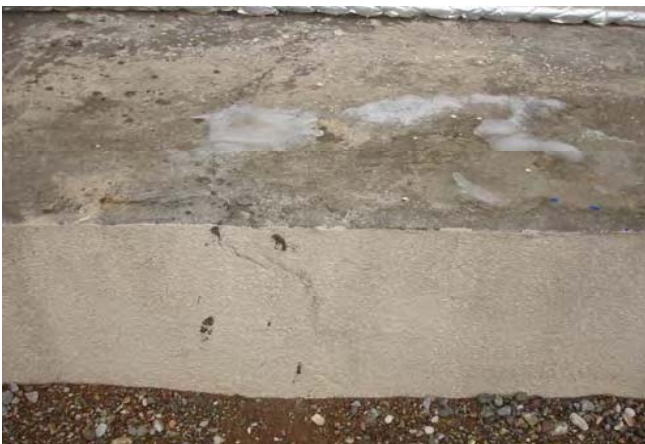
- Numerous cracks in the sidewalks and 45-degree cracks in the border post interior and exterior walls were observed “almost everywhere”. The 45-degree cracks could be shear cracks caused by differential settling. Site Photos 7 and 8 show examples of cracks in the sidewalks and walls.

Site Photo 7: Cracks in sidewalk (Project 12807)

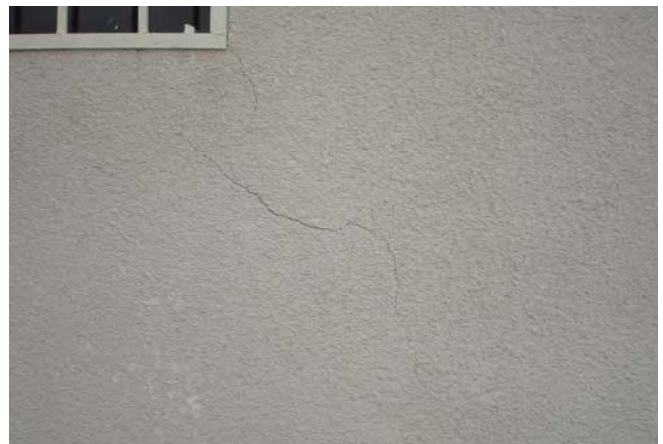
Site Photo 8: 45 degree crack in exterior walls (Project 12807)

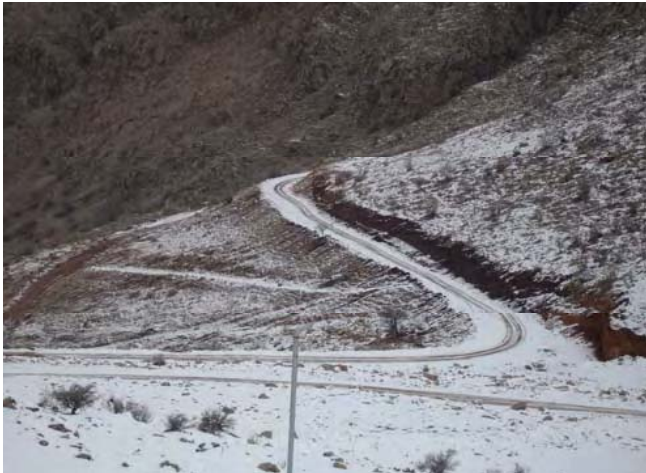
Site Photo 9: Access road (Project 12809)

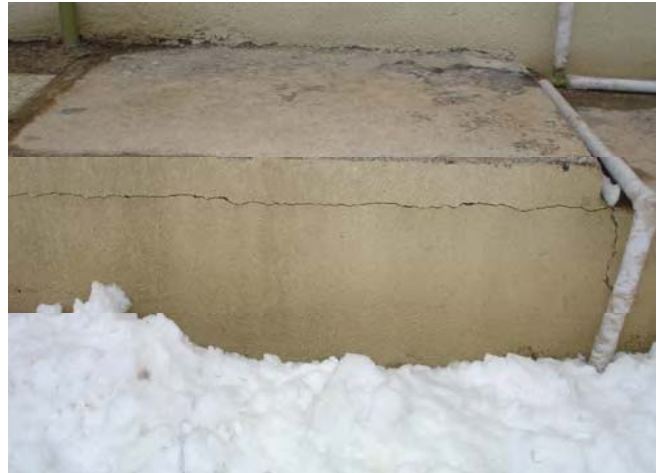
- Numerous cracks in the sidewalks and interior walls were observed. Site Photo 10 shows cracks in the sidewalks.
- Cracks could be due to poor quality workmanship or differential settling. Base plates for generators and fuel tanks were not properly secured.

Site Photo 10: Cracks in sidewalks (Project 12809)

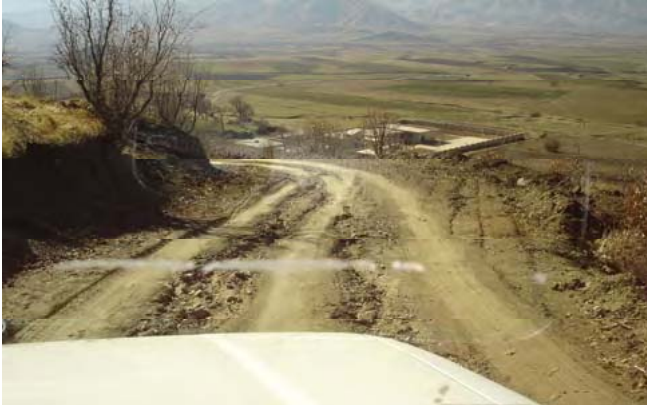
- No perimeter security fences or gates were present.
- The road to the border post was reported as difficult to access during the rainy or snowy seasons. Site Photo 11 shows the access road to the border post.
- The structural steel retrofit required due to deflection of I-beams was in-progress. Steel angle supports mounted to block walls were observed to be of poor construction.
- Potable water was reported trucked in for use and users reported they are concerned about the quality and quantity of the water. No filtration or sterilization (except boiling) of the water was available.

Site Photo 11: Access road (Project 12827)

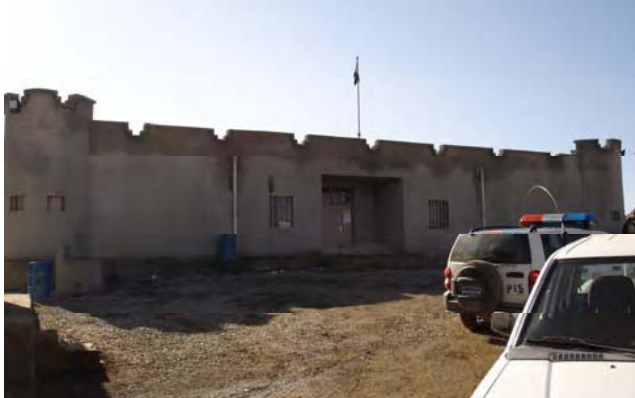
Site Photo 13: Front exterior view (Project 12831)

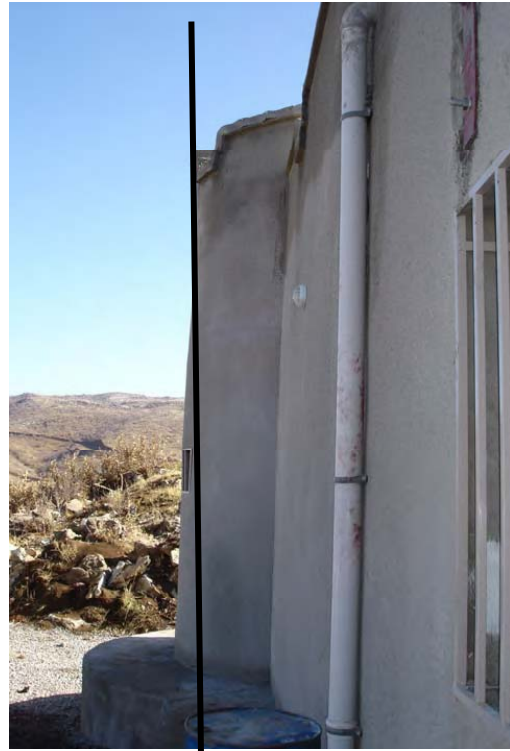
- Spot welds on the generator roofing appeared to be poor quality.
- Insufficient mastic in voids between roof tiles was noted.
- Surface of exterior walls was not straight (inward curvature) and poor finishing was observed. Site Photo 14 shows the exterior wall with a straight-line superimposed on the picture.

Site Photo 14: Front exterior view showing inward curvature of wall (Project 12831)

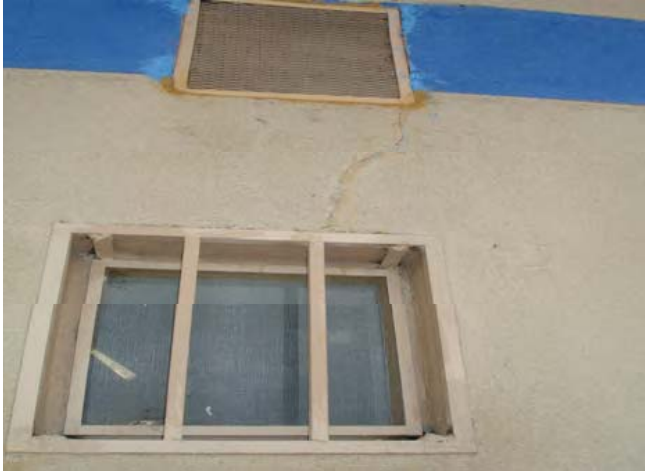
- 45-degree cracks in the border post exterior walls were observed. 45-degree cracks could be shear cracks caused by differential settling of the building foundation. Site Photo 15 shows an example of the cracks observed in the exterior walls of the border post.

Site Photo 15: 45 degree cracks in exterior wall (Project 12834)

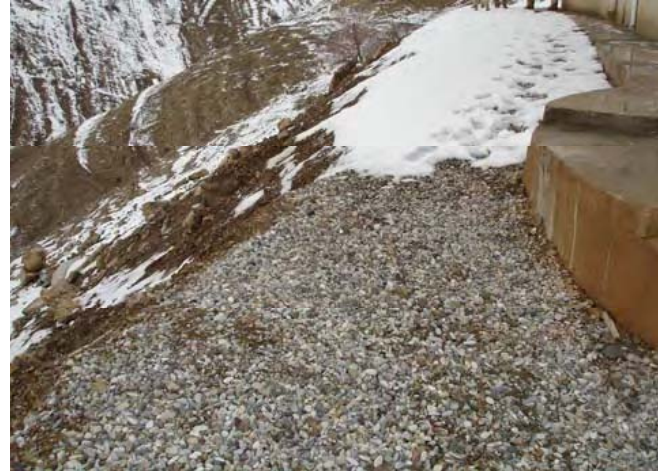
- The sidewalks around the border post showed numerous cracks. More importantly, there were cracks between the border post and sidewalks that could be signs of lateral movement of the sidewalks. Within several feet of the border post is a steep down gradient bank with no retaining walls constructed. With no retaining walls to support the soil, failure of the bank could negatively impact the structural integrity of the buildings foundation. Site Photo 16 shows the sidewalk and down gradient bank.

Site Photo 16: Steep down gradient bank within several feet of sidewalk (Project 12834)

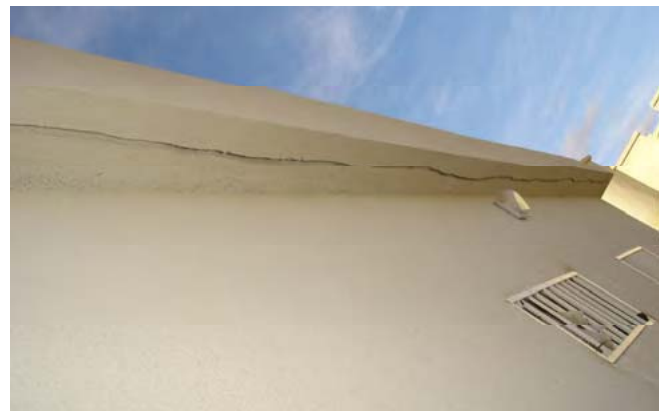
Site Photo 18: Cracks on exterior wall (Project 12835)

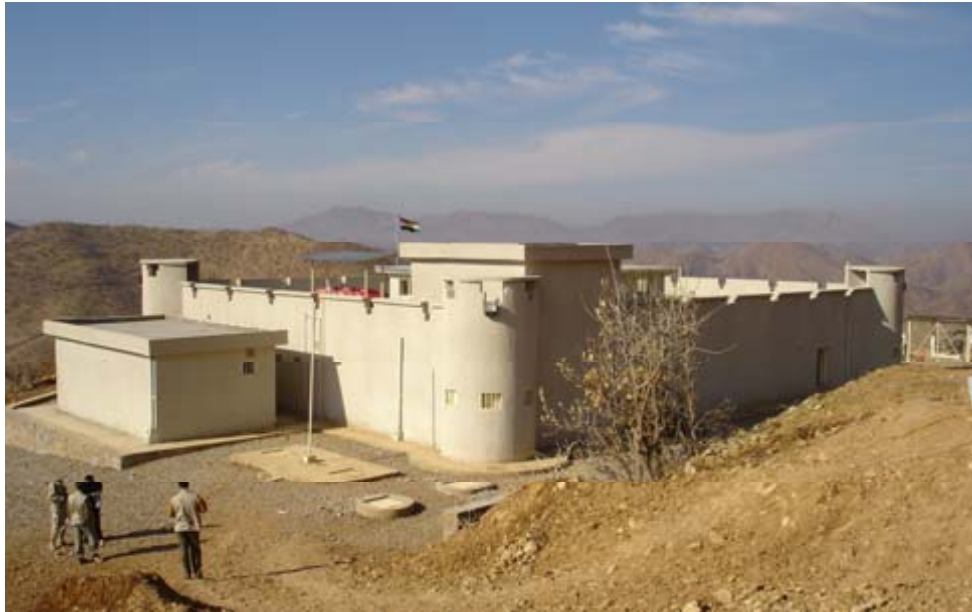
- In general, the quality of construction of this border post was noticeably better than the other border posts inspected. Exterior finishing and welding showed no discrepancies. Site Photo 19 shows the exterior view of the border post.
- No perimeter security fences or gates were present.
- The road to the border post was reported as difficult to access during the rainy or snowy seasons.
- Potable water was reported trucked in for use and users reported that they are concerned about the quality and quantity of the water. No filtration or sterilization (except boiling) of the water was available.

Site Photo 19: Exterior view of border post – Project 12836

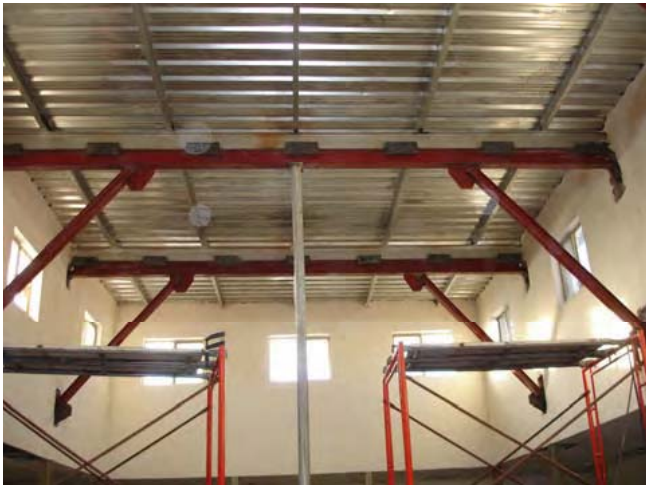
Site Photo 20: Steel retrofit in progress (Project 12850)

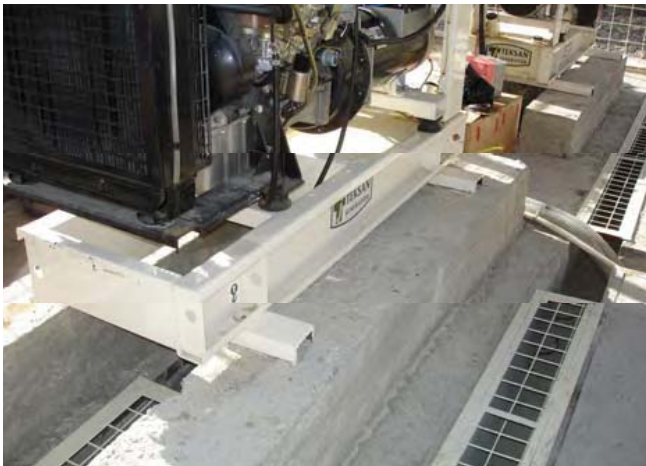
- No perimeter security fences or gates were present.
- The generator was not anchored to the concrete base. Site Photo 22 shows the generator and concrete base.
- Spot welds on the generator roofing appeared to be of poor quality.
- Poor finishing and broken concrete was observed at the septic tank cover.
- Roof water tanks base girders were not fastened to the concrete foundation. Site Photo 23 shows the water tank base.

Site Photo 22: Generator mounted on concrete base (Project 12855)

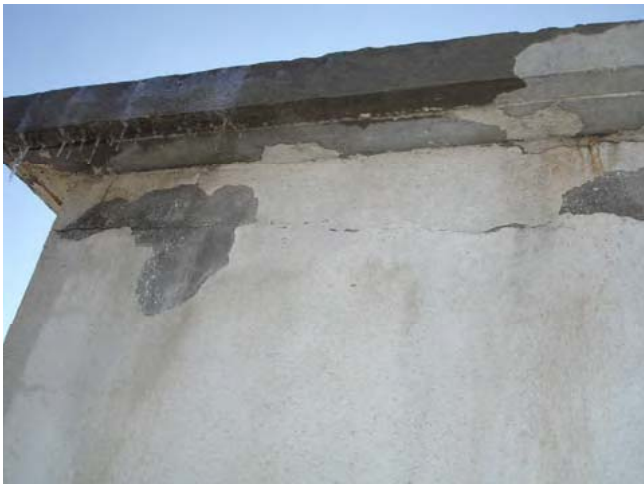
- Cracks in the concrete were observed extensively throughout the exterior of the three buildings, possibly due to differential settling of the foundation and/or poor construction. Site Photo 26 shows exterior wall cracks.

Site Photo 26: Cracks in exterior walls (Project 20558)

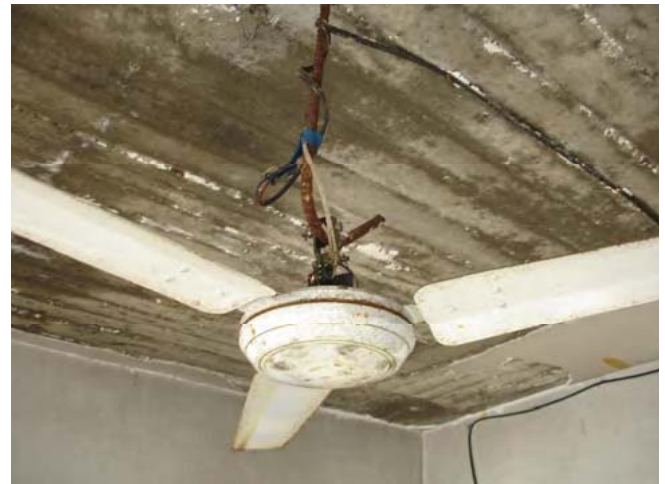
- Finishing of interior walls was extremely poor, showing cracks, staining, and peeling of plaster.
- Electrical installation was extremely poor with numerous areas of exposed wiring. Site Photo 27 shows exposed electrical wiring for ceiling fan.

Site Photo 27: Ceiling fan with exposed wiring (20558)

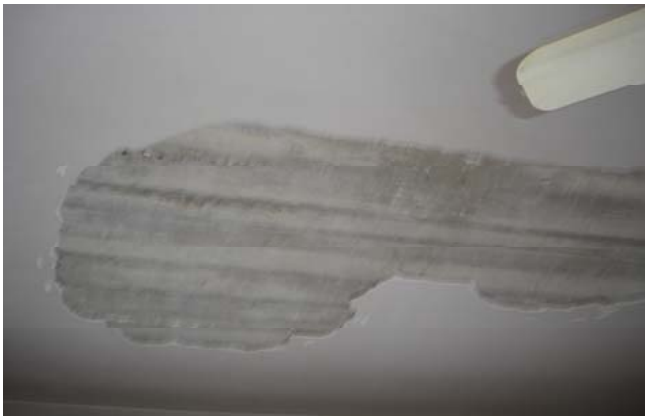
Site Photo 28: Damaged ceiling plaster (Project 20570)

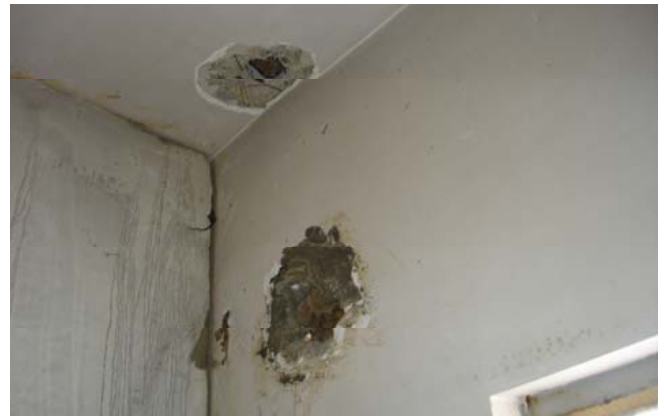
Site Photo 29: Holes in wall of kitchen area (Project 20570)

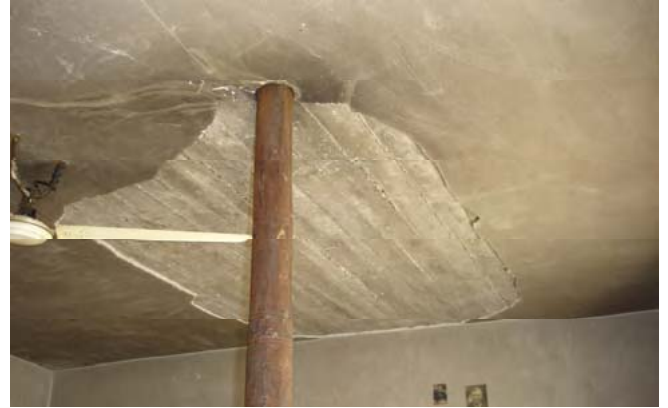
Site Photo 31: Deteriorating plaster ceiling (Project 20571)

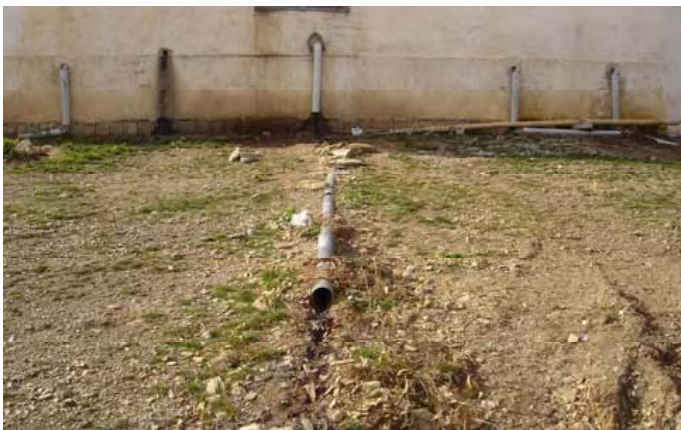
Site Photo 32: Sewer outfall behind border post (Project 20572)

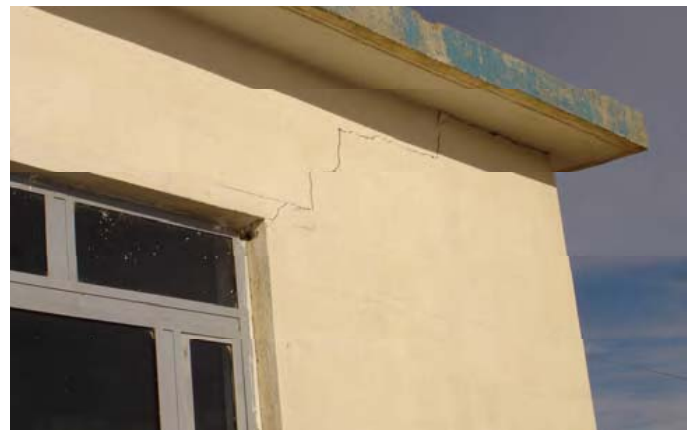
Site Photo 33: Cracks in exterior wall (Project 20572)

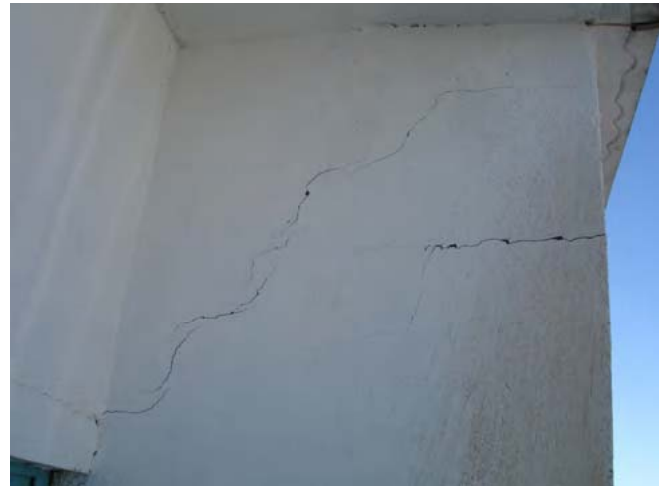
Site Photo 35: Cracks in exterior wall (Project 20573)

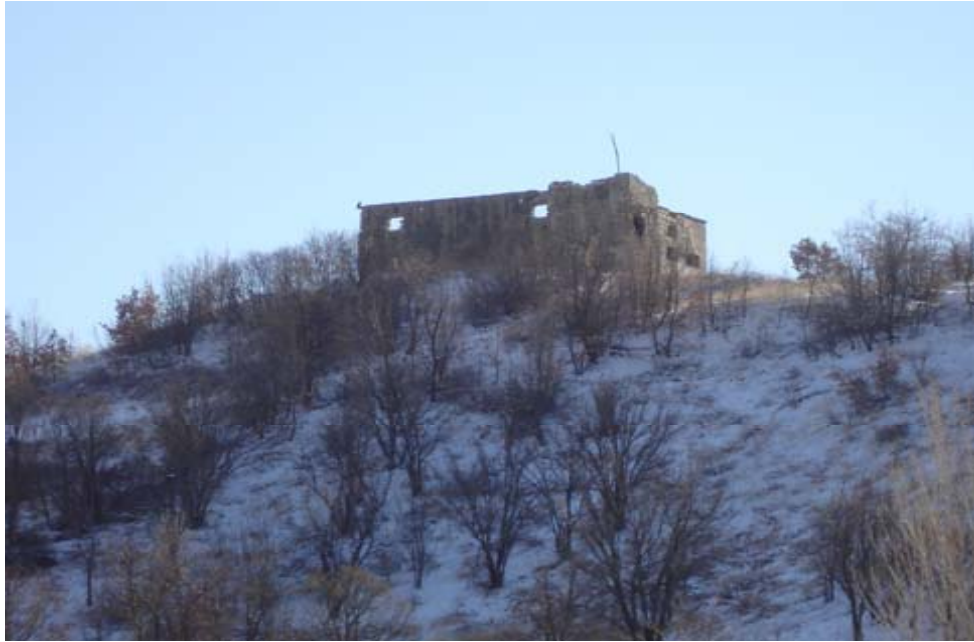
- The border post was reported to be surrounded by a mine field and access was deemed too dangerous to approach. Site Photo 36 shows the exterior of the border post. It could not be determined if renovation of the facility was completed or to what quality the renovation was accomplished.

Site Photo 36: Exterior view of border post - Project 20574

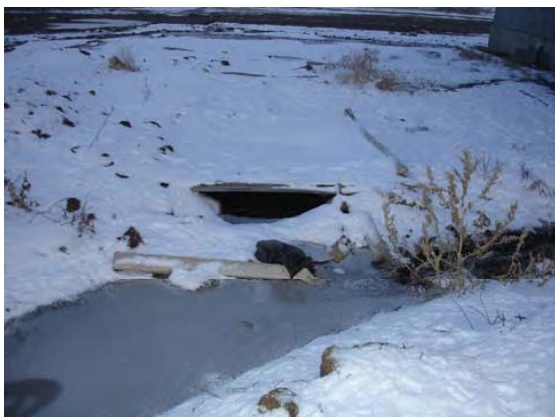
Site Photo 37: Sewage overflow area (Project 20575)

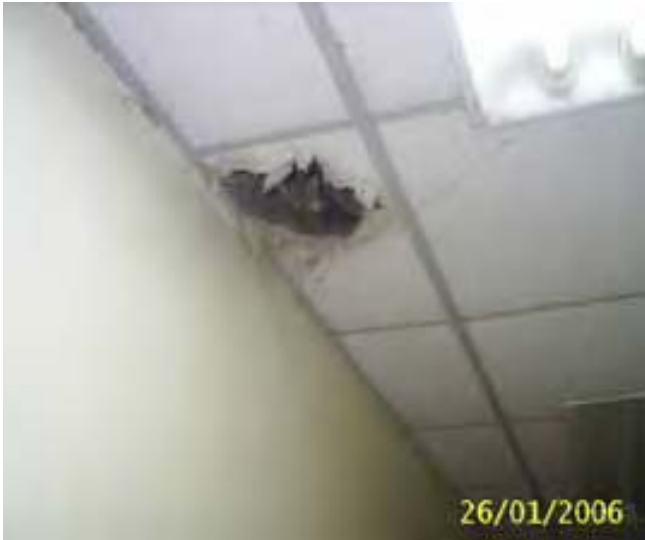
- Suspended ceiling showed signs of water damage, reportedly from leaking pipes. Site Photo 51 shows an example of a water damaged suspended ceiling tile.
- Standing water was observed adjacent to the exterior of the building from water pipe leaks.
- Painted walls were blistering, possibly due to improper preparation and/or low quality paint.
- The bathrooms showed signs of water leakage and tile damage. Site Photo 52 shows a bathroom with water leaks and tile damage.
- Water pipes in the basement were leaking, causing water to accumulate on the concrete floor. Site Photo 53 shows water accumulated in the hospital basement.
- Doors and locks were reported to be of low quality.

Site Photo 51: Water damaged suspended ceiling (Project 16124)

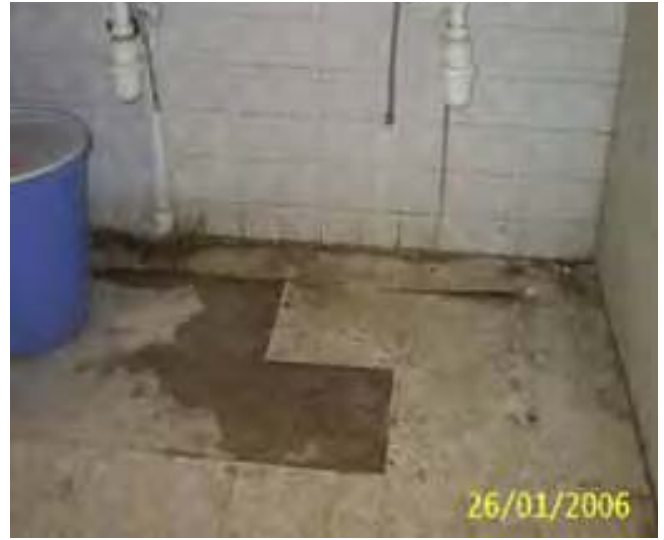
Site Photo 52: Damaged tile in bathroom (Project 16124)

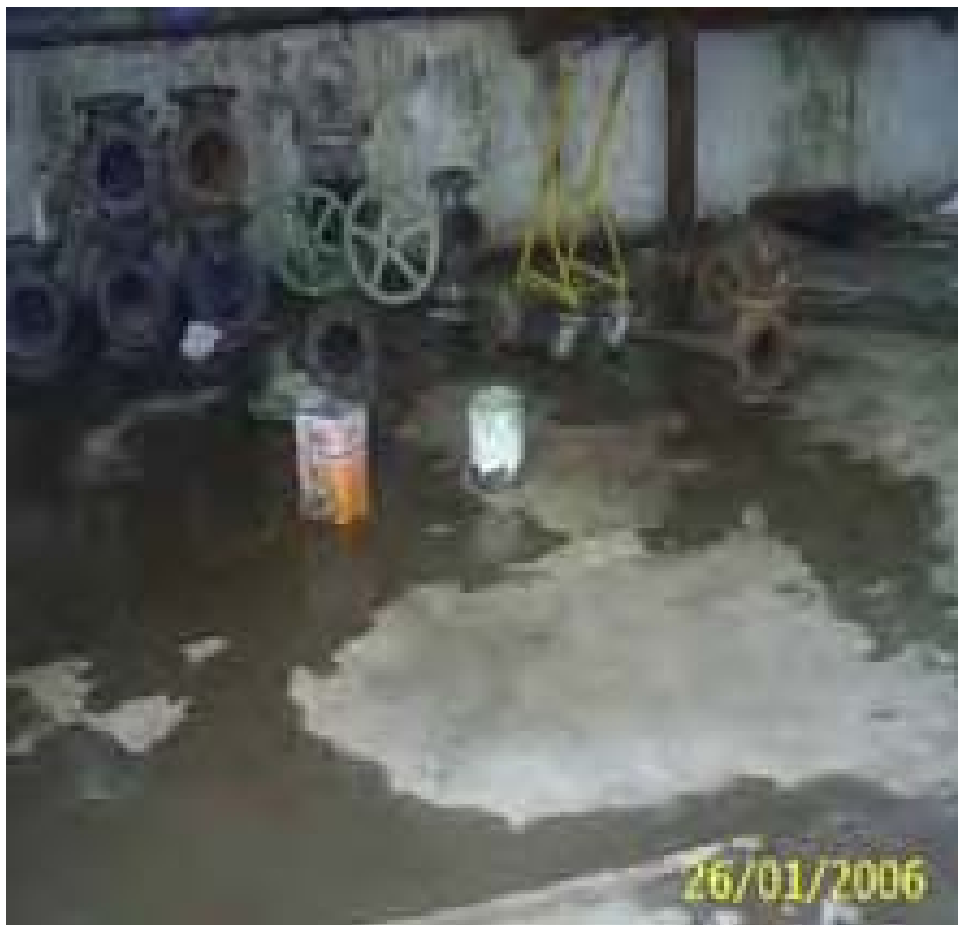
Site Photo 53: Water leaking in hospital basement (Project 16124)

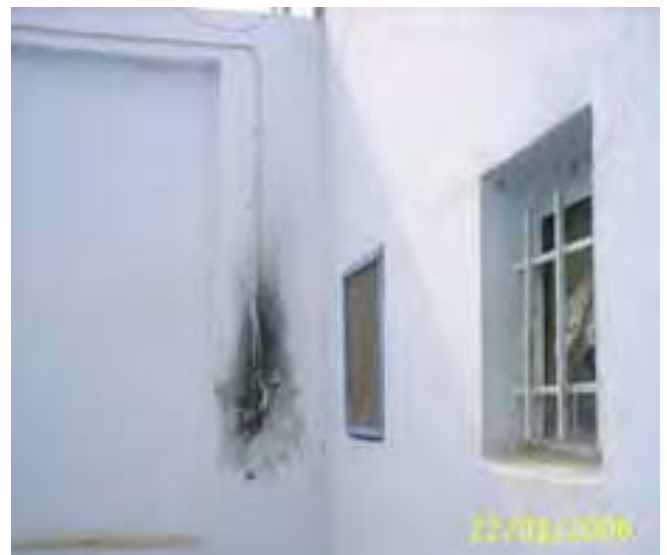
The IRMS database listed the project as 100 percent complete on 27 July 2005. The project included new construction of four guard towers, a parking lot, and an officer's room and renovation work. Site Photo 60 shows one of the corner guard posts. A new 63 KVA generator with two fuel tanks was on site. Discrepancies noted during the site visit included electrical and plumbing systems. Electrical panels were exposed, and an electrical outlet showed possible signs of recent fire damage. Site Photo 61 shows the fire damaged electrical outlet.

Site Photo 61: Fire damaged electrical outlet (Project 18334)

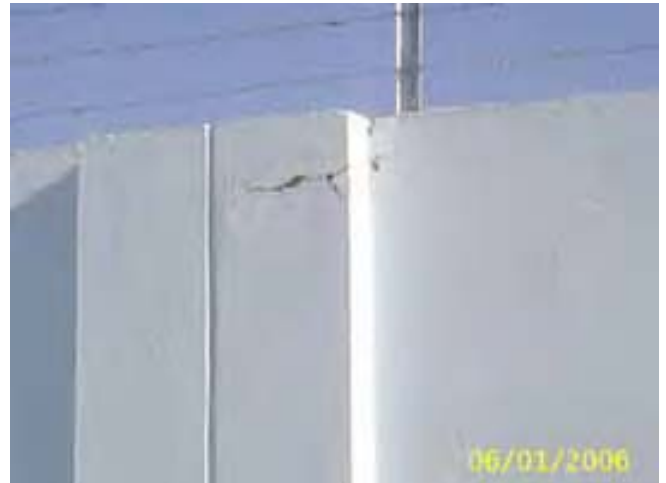
The IRMS database listed the project as 100 percent complete on 30 August - 2005. The project was new construction and included perimeter security walls, entrance gates, guard towers, and a nine-room building. Site Photo 62 shows the exterior of the building. A generator and covered parking area were also located within the perimeter walls. A crack was observed in the perimeter wall, although no other discrepancies were noted. Site Photo 63 shows the crack in the exterior perimeter wall.

Site Photo 63: Crack in perimeter wall (Project 19111)

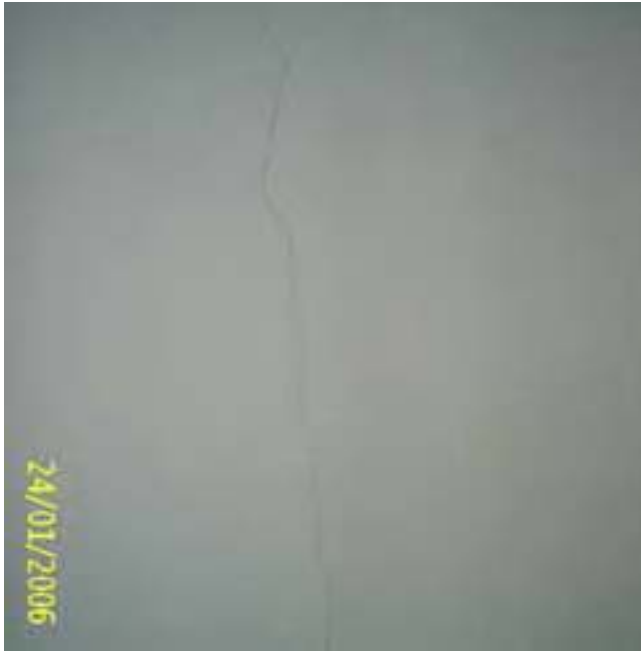
The IRMS database listed the project as 100 percent complete on 16 May 2005. The project consisted of the renovation of existing structures and new construction. Perimeter security walls topped with concertina wire, entrance gates, and corner guard posts were complete at the time of the visit. Contract line item 10 (d) included \$12,000 for a generator. It was reported the contractor did not supply new generators because the Police Headquarters supplied the facility with generators. Discrepancies noted during the visit included numerous cracks in interior walls. Site Photo 64 and 65 show examples of cracks in the walls.

Site Photo 64: Cracks in interior wall (Project 19117)

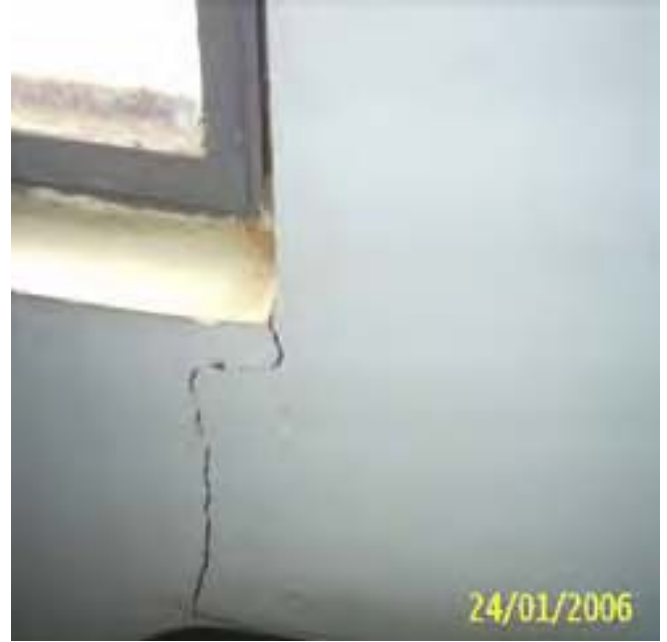
Site Photo 65: Wall cracks below window (Project 19117)

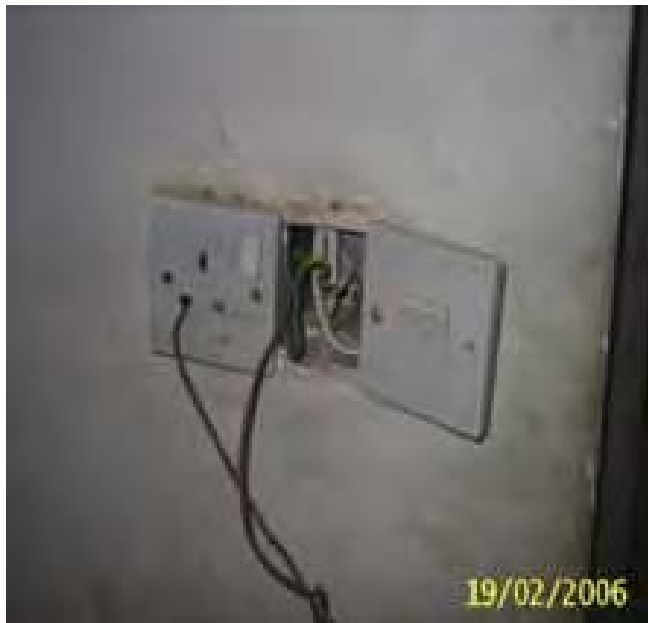
- Electrical systems had exposed wiring, broken fixtures, improper connections, and missing electrical covers throughout the entire police station. Site Photo 66 and 67 show examples of the electrical systems
- Interior and exterior paint was peeling due probably to low quality paint and/or improper preparation of the walls before painting. Site Photo 68 shows an interior wall with peeling paint.
- Numerous cracks were visible in the interior walls.
- Exterior walls were not completely finished, with exposed concrete block present.
- Roof tiles were not properly repaired and installed. Site Photo 69 shows an example of the damaged roof tiles.

Site Photo 66: Electrical wall switches (Project 19175)

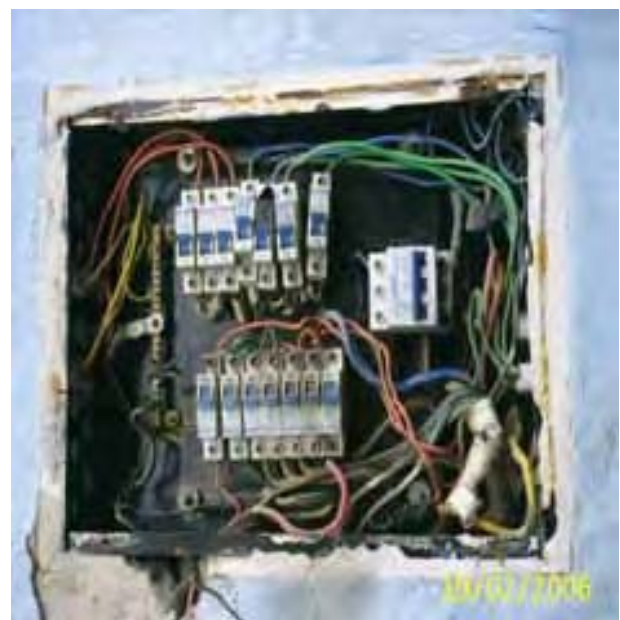
Site Photo 67: Electrical circuit breaker panel (Project 19175)

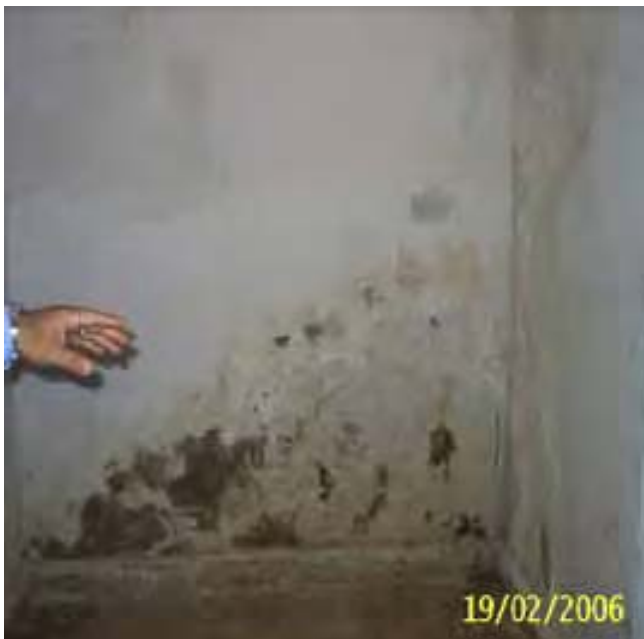
Site Photo 68: Interior wall with peeling paint (Project 19175)

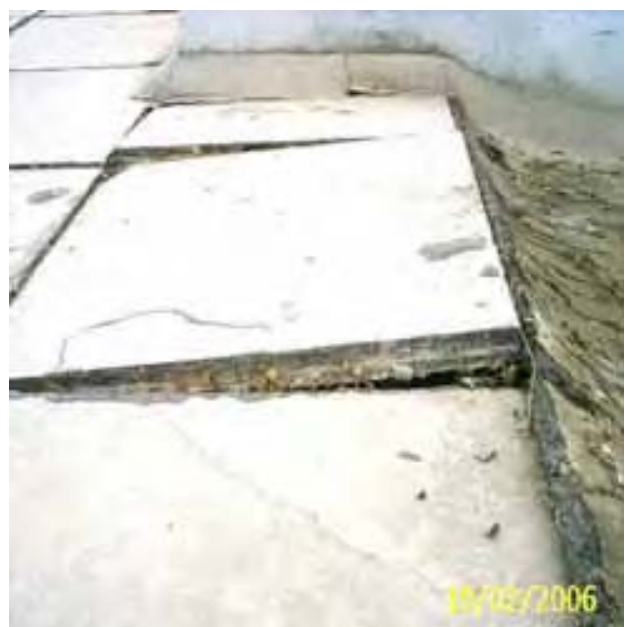
Site Photo 69: Damaged roof tiles (Project 19175)

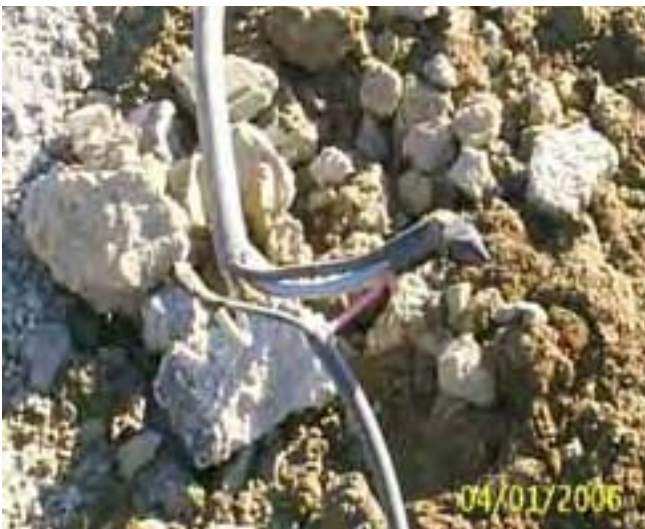
improper electrical connections. Site Photo 72 shows exterior electrical wiring located on the ground surface and Site Photo 73 shows interior lights with possible fire damage.

Site Photo 72: Exposed electrical wirings (Project 19179)

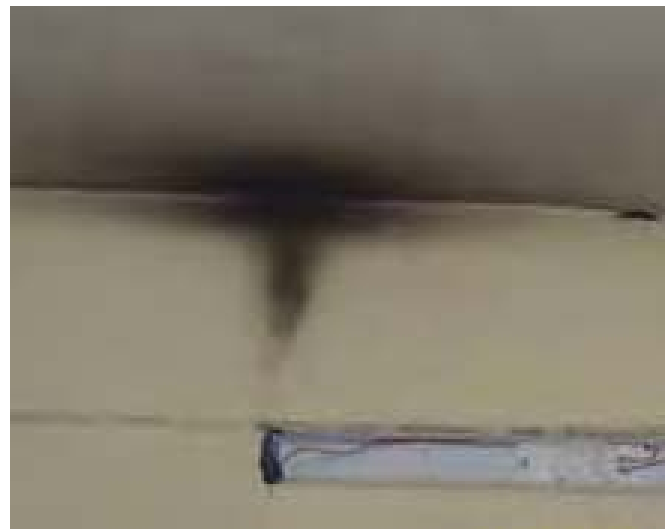
Site Photo 73: Interior electrical light with smoke damage (Project 19179)

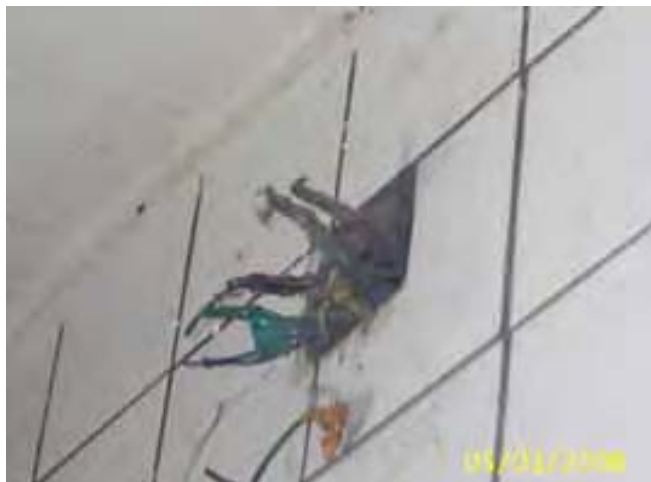
Site Photo 74: Exposed electrical wirings (Project 19181)

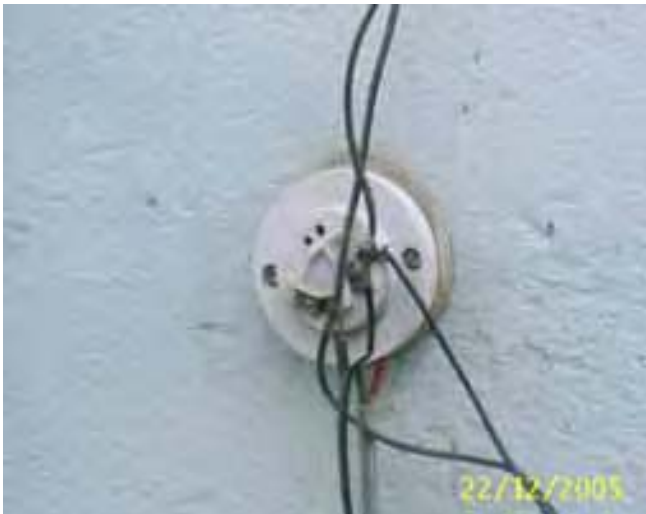
Site Photo 76: Exposed electrical wirings (Project 19189)

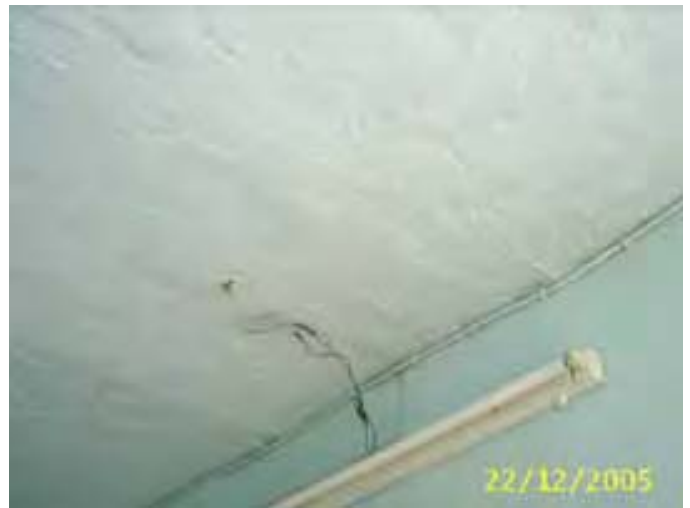
Site Photo 77: Roof and inconsistent ceiling texture (Project 19189)

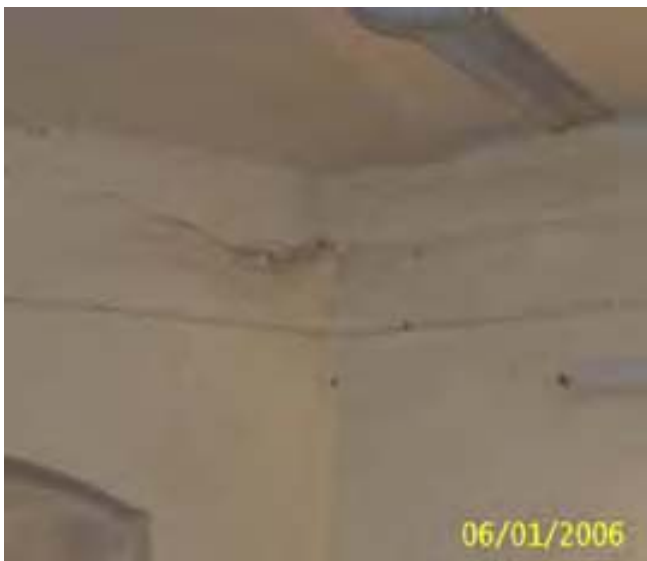
Site Photo 78: Cracks and peeling paint in walls and ceiling (Project 19227)

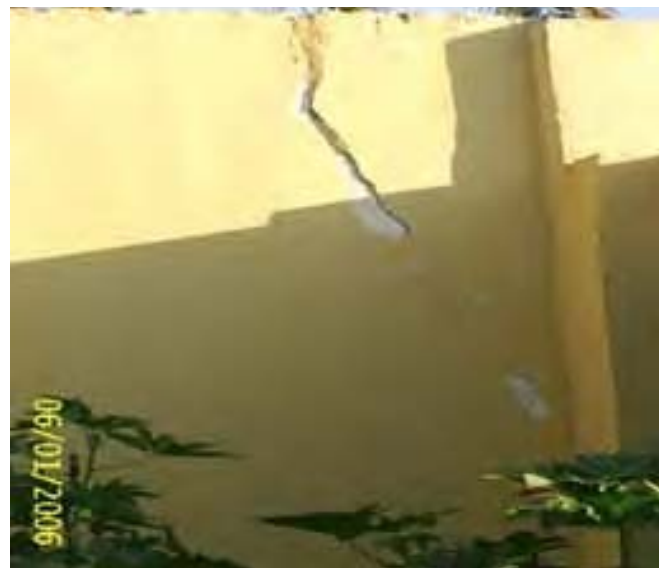
Site Photo 79: Crack in perimeter wall (Project 19227)

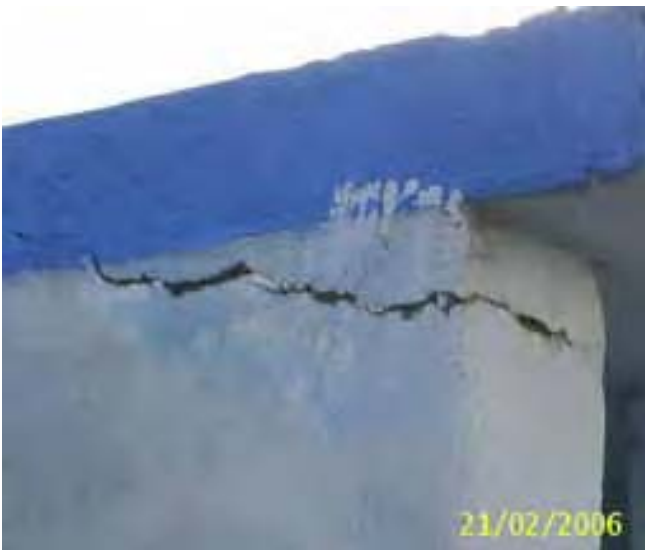
Site Photo 80: Cracks in exterior walls (Project 19230)

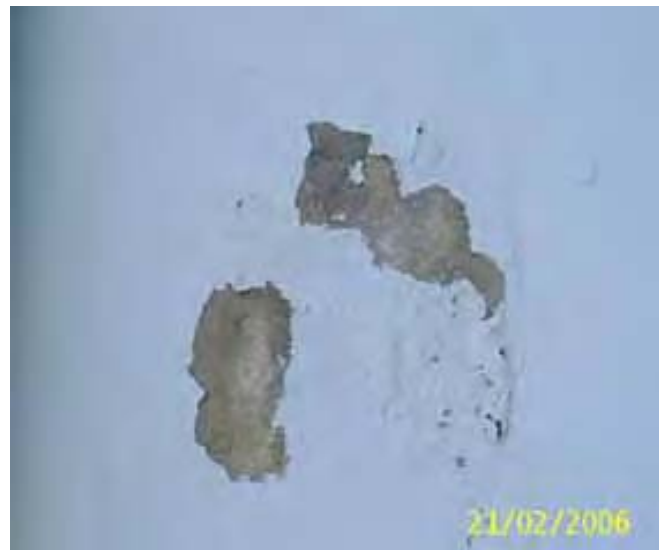
Site Photo 81: Peeling paint in interior walls (Project 19230)

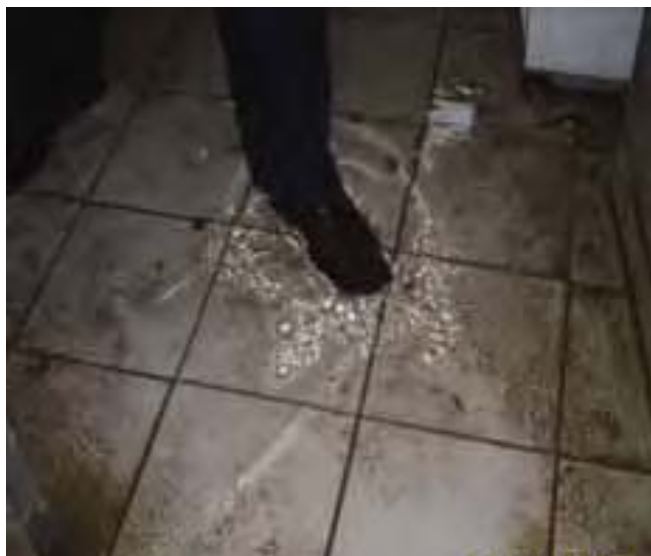
Site Photo 82: Pooled water on bathroom floor (Project 20324)

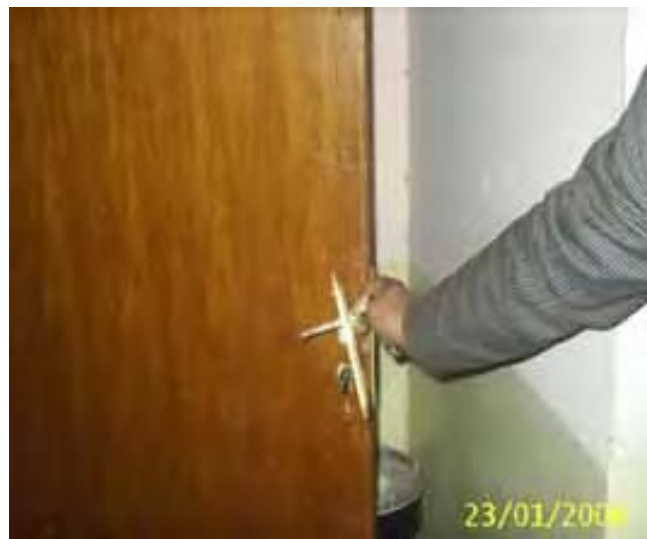
Site Photo 83: Broken door handle (Project 20324)
